Use of Resin Infiltrate for the Treatment of White spot Lesions on Dental Enamel: Case Report

Rosa Maria Pereira Moisés Barbosa de Andrade*^a; Ruchele Dias Nogueira^a; Maria Angélica Hueb de Menezes-Oliveira^a; Cesar Penazzo Lepri^a; Vinícius Rangel Geraldo-Martins^a

^aUniversity of Uberaba, Stricto Sensu Graduate Program in Dentistry. SP, Brazil.

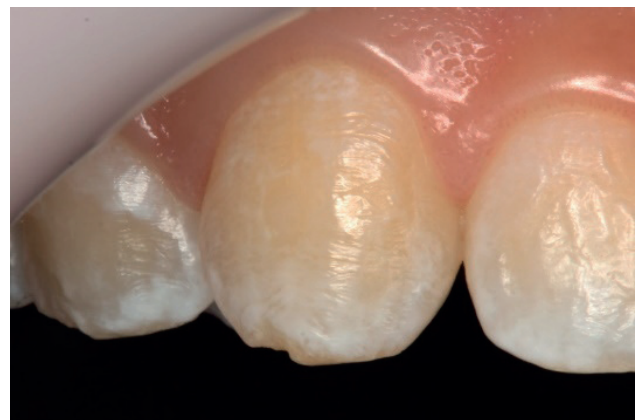
Figure 1 - Initial clinical aspect of the lesion of white spot lesion tooth 13.

A 16-year-old female patient was chosen, who had a good general health and presented the tooth 13 with active white spot lesion on the face of the incisal tooth. (Figure 1). The selected tooth got the score 2 of the ICDAS criterion-II (International Caries Detection and Assessment System) for diagnosis of caries.¹⁶ The evaluated tooth showed no restorations, but a small fracture in the incisal face. According to the literature, patients in this age group comprise a group with a high incidence of white spot lesions in the enamel, mainly due to the lack of proper hygiene.¹⁷

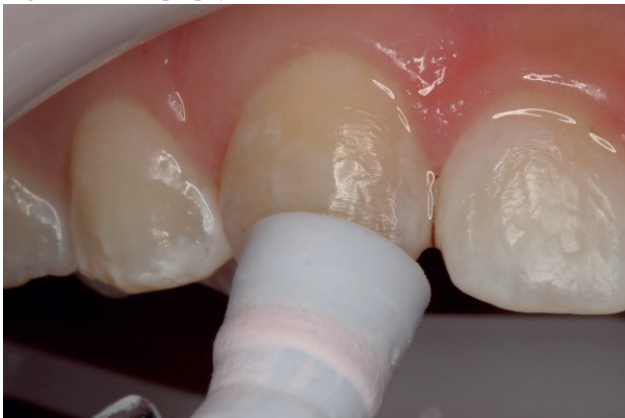
Figure 2 - Prior prophylaxis.

The tooth received prophylaxis with prophylactic paste and rubber bowl (Figure 2). Prior to the reading of the initial color

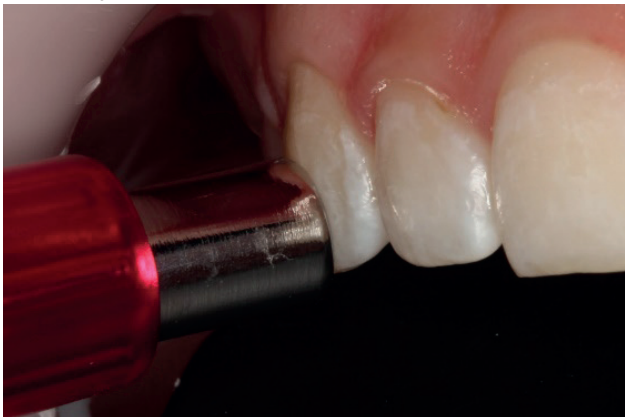
Figure 3 - Reading of the initial color of white spot and the enamel adjacent to the lesion

of white spot and the enamel adjacent to the lesion with the spectrophotometer Easysshade Compact Advance V (Wilcos do Brasil Indústria e Comércio Ltda., Petropolis-RJ, Brazil) (Figure 3), in accordance with the CIELCh system, where L represents the brightness, C represents the chroma and h represents the tone or hue of the face of the tooth. The initial analysis showed, for the white spot lesion, the values of L=-0.5; C= 5.4 and h= 1.5. In accordance with the spectrophotometer, these values lead to color A3 of the scale Vita Classic (Wilcos do Brasil Indústria e Comércio Ltda). Whereas to the enamel adjacent to the lesion, the initial values were found for L=9.1; C= 11.2 and h=0.2, corresponding to the color a3,5 in Vita Classic scale.

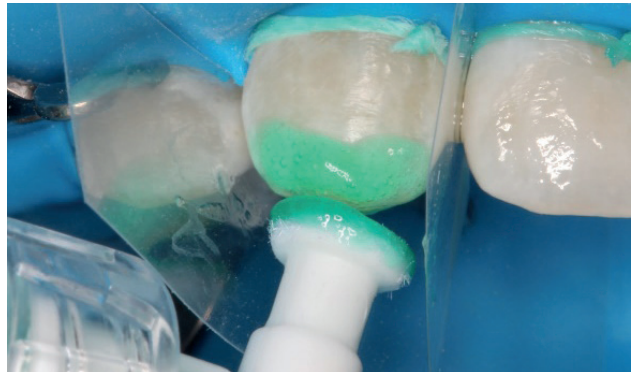
Figure 4 - Conditioning of the white spot lesion with Icon-Etch (hydrochloric acid 15%) for 2 minutes.

The treatment of white spot lesions was performed according to the instructions provided by the manufacturer of the resin infiltrating Icon (DMG, Hamburg, Germany). After the absolute isolation of the anterior teeth, the conditioning of the white spot lesion was performed with Icon-Etch hydrochloric acid (15%) for 2 minutes (Figure 4), followed by washing with water for 30 seconds. After the removal of the Icon-Etch, the surface was dried with compressed air for 30 seconds, followed by the application of Icon-Dry (99% ethanol) for 30 seconds (Figure 5) and drying with compressed air for 30 seconds.

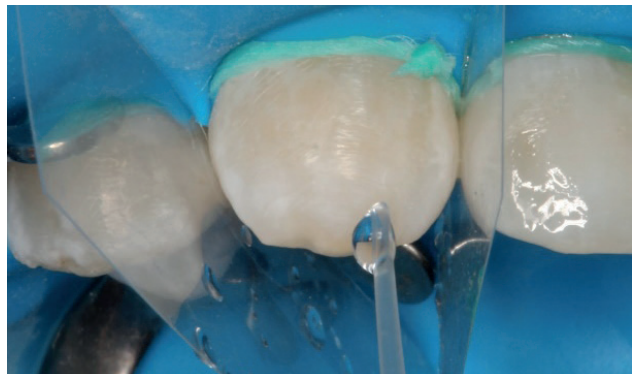
Figure 5 - Application of Icon-Dry (99% ethanol) for 30 seconds.

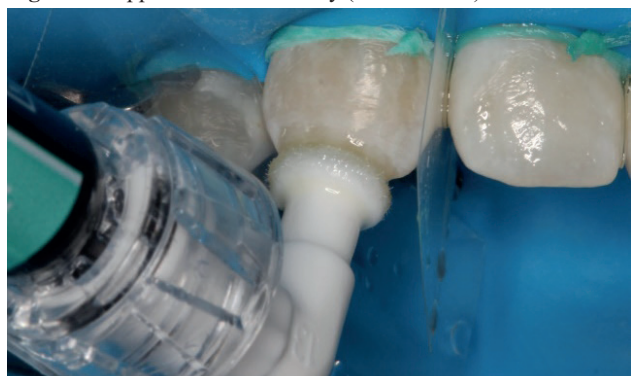
Figure 6 - Application of Icon-Dry (99% ethanol) for 30 seconds.

After drying, the Icon-Infiltrate (resin matrix based on methacrylates, initiators and additives) was applied on the surface (Figure 6), leaving it to operate on the demineralized enamel for 3 minutes. Then, the excesses of the infiltrating resin were removed from the proximal surfaces with floss and, subsequently, photo activation was performed of the product for 40 seconds (Figure 7) with the light curing unit Radium-cal (1200mW/cm²; SDI Limited, Bayswater, Victoria, Australia). After the application of light, the Icon-Infiltrate was reapplied on the enamel surface of the cured unit. Then polishing of the treated surface was performed with abrasive rubber tips (Figure 8). For the purpose of standardization, the treatment will be performed by the same researcher.

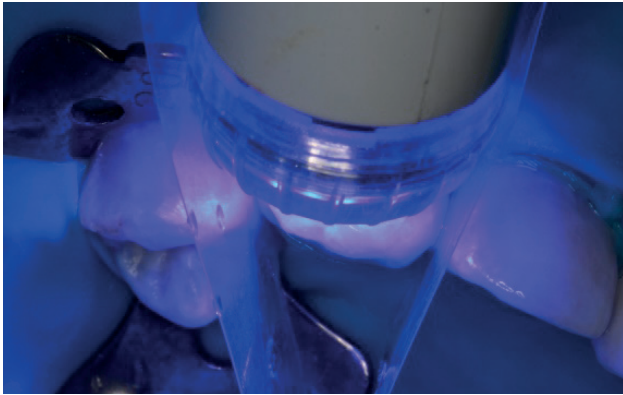
Figure 7 -Photo activation for 40 seconds.

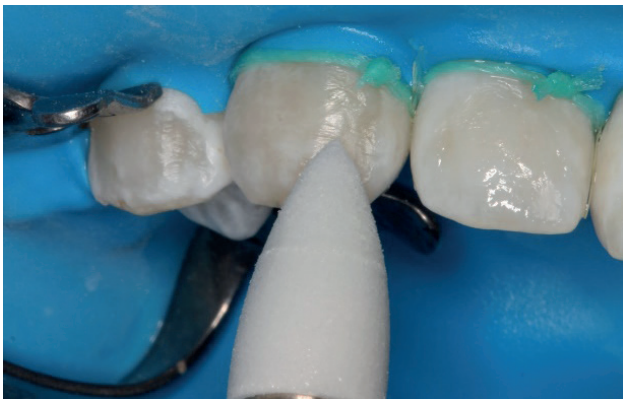
Figure 8 - Polishing of the photo activated enamel surface.

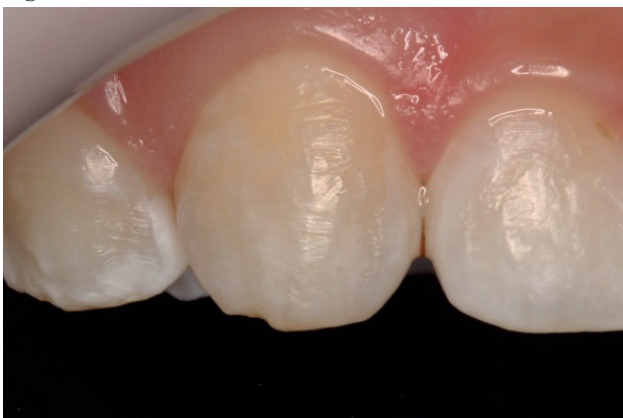
Figure 9 - Final result.

After the treatment, the color of the treated enamel was again evaluated by a spectrophotometer. At the end of treatment (Figure 9), it was observed that, clinically, the result was effective, because it was able to change the color of the white spot, turning it more similar to other regions of the tooth. In accordance with the final reading of the spectrophotometer, the treated lesion presented $L=2.4$; $C=4.8$ and $h=0.2$. This shows that the treated lesion was clearer, less saturated and with yellowish tone similar to the adjacent enamel. According to the equipment, the treated lesion corresponded to the color A3,5 Vita Classic scale, the same y of the adjacent enamel.
